July 2014

SHAKE AND BREAK: THE HESSI OVERTEST MISHAP

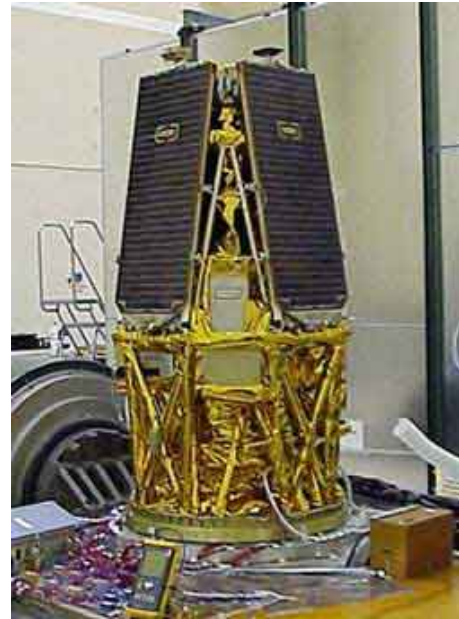
This photo was taken at JPL shortly before the vibration test anomaly which damaged the spacecraft

Proximate (i.e., immediate) Cause. The MIB found that a mechanical failure in the shaker's support structure caused physical contact between a portion of the slip table and the granite mass. The resulting stiction caused the shaker system to present highly non-linear gain characteristics to the control system. Attempting to overcome the stiction, the controller calculated a very high forcing function that overshoot the desired sine-burst amplitude and damaged major spacecraft structural elements.

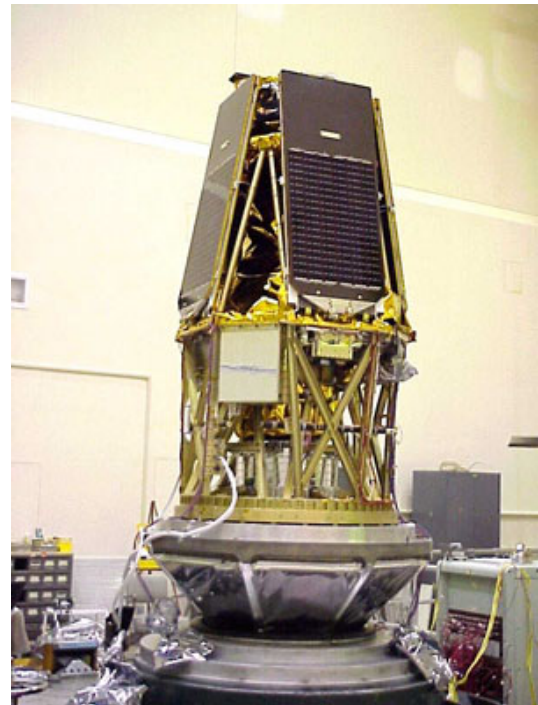
Test Setup. The HESSI spacecraft was brought to the JPL Environmental Test Laboratory and mounted to an adapter ring. The adapter was then mounted to the magnesium alloy slip table via an aluminum fixture plate in preparation for testing in the spacecraft's X-axis. Force gages were placed between the spacecraft adapter ring and the fixture plate to measure the force input to the spacecraft.

The spacecraft adapter ring and aluminum fixture plate are clearly shown in a HESSI test configuration

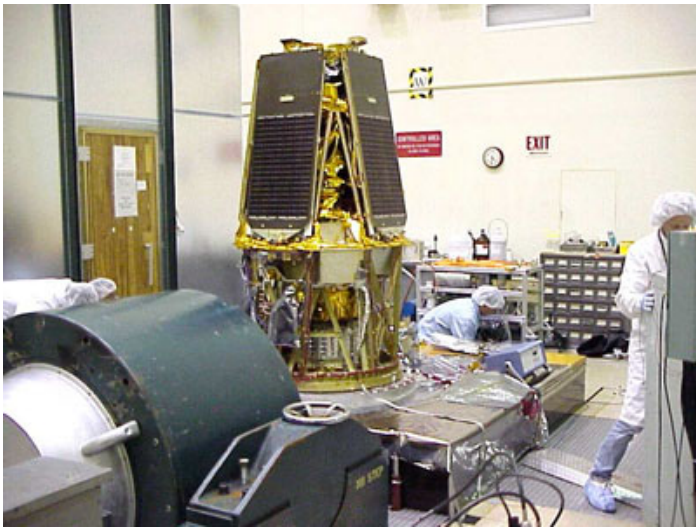
A Ling Model A-249, JPL's largest shaker, was attached to the slip table to provide lateral excitation. The shaker and granite mass were mounted directly to an isolated floor section. A thin oil film separated the slip plate from the granite reaction mass. (The granite serves as an isolator, preventing the vibration from being induced into the laboratory floor.)

Preparing the Ling shaker and slip table for HESSI dynamic testing

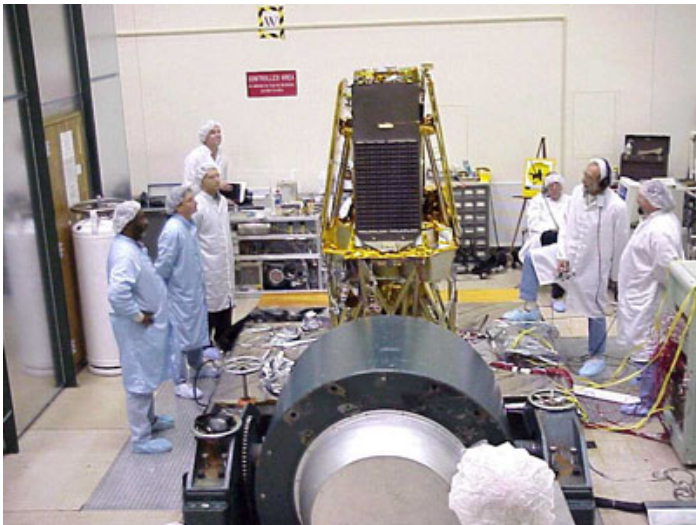
HESSI during an X-axis vibration test.

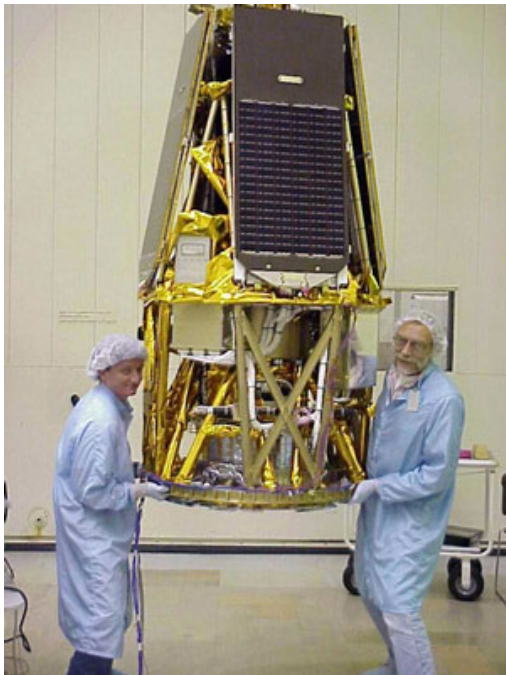
Mishandling at JPL was not a contributing cause. (In this photo, the HESSI spacecraft is actually suspended from cables)
